# Bushfire test to AS 1530.8.1 on Weepguard weephole barrier installed in brick coarse work with non raked mortar detail

## Testing Report

Report number: EP127522

Client: AC & L Marlborough

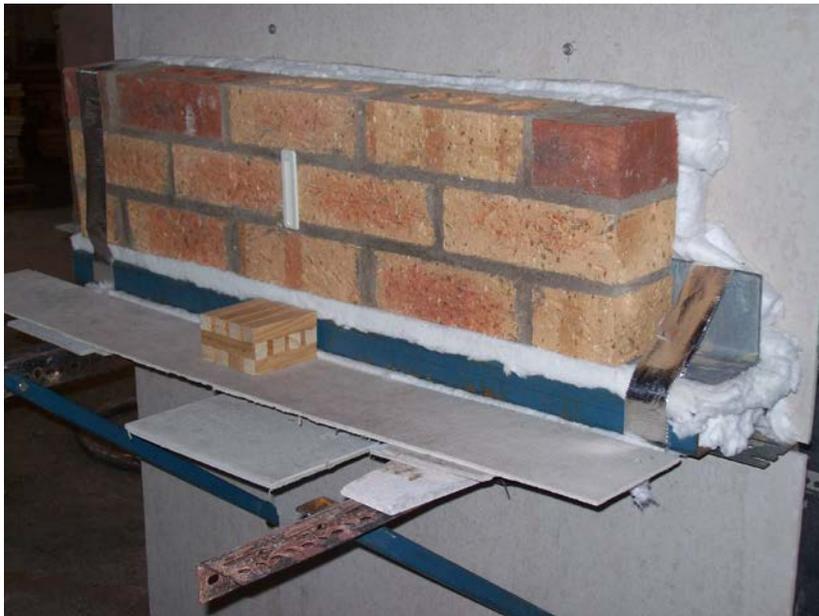
Figure 3: Weepguard as installed in wall for testing to AS 1530.8.1.

The Weepguard weephole barrier (Figure 2) was installed in an approximate 1m wide three coarse high section of structural brick wall with non raked coarse work (See Figure 3). The Weepguard was installed in the weephole penetration in the second coarse as is typical in building applications in the middle section of the wall (See Figure 3). The Weepguard/wall specimen was mounted onto the test carriage so that the Weepguard specimen was aligned with the centre of the radiant panel. The wall was positioned approximately 50 mm away from a 4.5 mm thick cement sheet that extended from the base of the wall specimen to the top of the test rig. This created a cavity similar which simulates that behind a brick wall in a building application. The ends of the wall specimen and the top were insulated by filling gaps between the wall and the cement sheet using ceramic blanket as were all other openings (Figure 4).

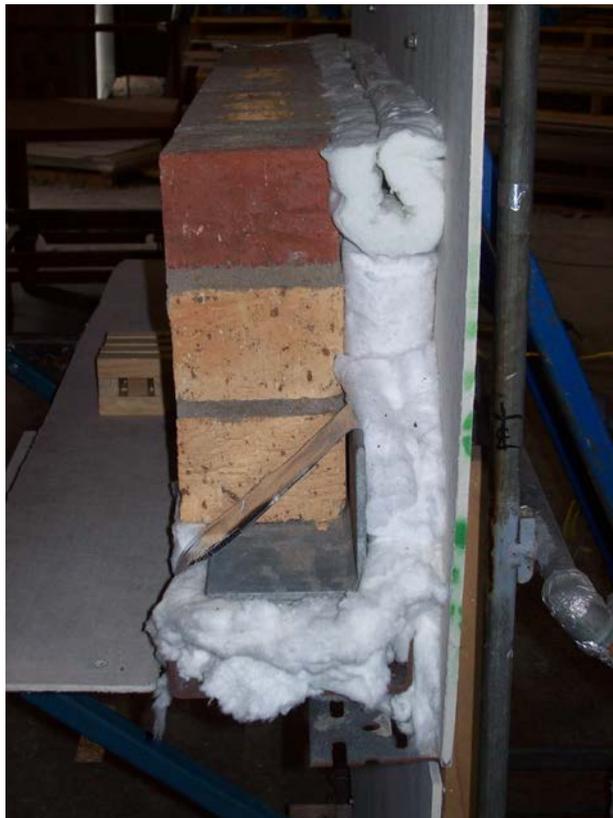
Figure 4: Side view of Weepguard/wall specimen installation showing insulation of cavity at the end and top of the sample.

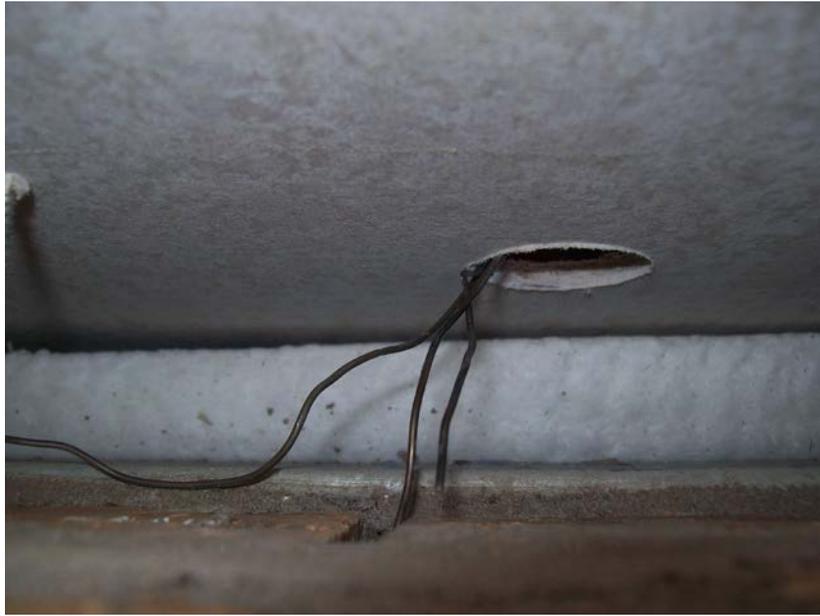
Figure 6: Thermocouples in weephole cavity and in cavity between cement sheet and brick wall.

The test procedure is based on AS 1530.8.1<sup>1</sup> and a  $12.5\text{ kW/m}^2$  radiant heat exposure (see Figure 5). The exposure comprises a rapid increase to  $12.5\text{ kW/m}^2$  which was held for 2 minutes before a slow decline. The total time of the radiant heat exposure profile extends to 10 minutes. The lower limit of  $\sim 3\text{ kW/m}^2$  observed in Figure 5 is a limitation of the distance the carriage can be moved away from the radiant panel. To simulate possible embers or foliage fires at ground level below the Weepguard installation, a Class A crib ignition source was placed 100 mm under the installed Weepguard barrier. The crib was placed in position within 15 seconds post its ignition and as per standard the installed Weepguard/wall specimen was then exposed to the radiant heat profile within 15 seconds and this was deemed as the start of the test. Thermocouples were used to measure the air temperature in the weep-hole cavity directly behind the Weepguard barrier, the air temperature in the cavity formed between the brick wall specimen and the cement sheet, and the temperature of the cement sheet surface (non fire side within formed cavity). Radiometers were placed 365 and 250 mm behind the back face of the cement sheet wall in line with the crib position. Thermocouple installation is shown in Figure 6.

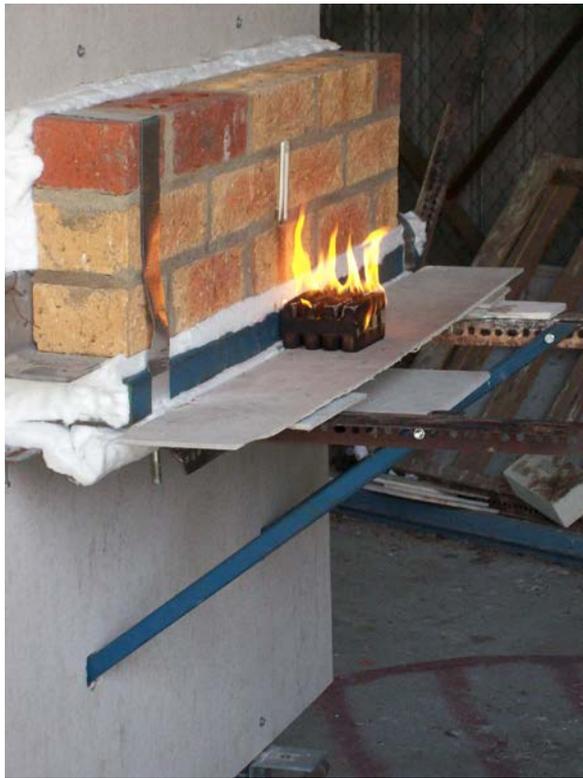
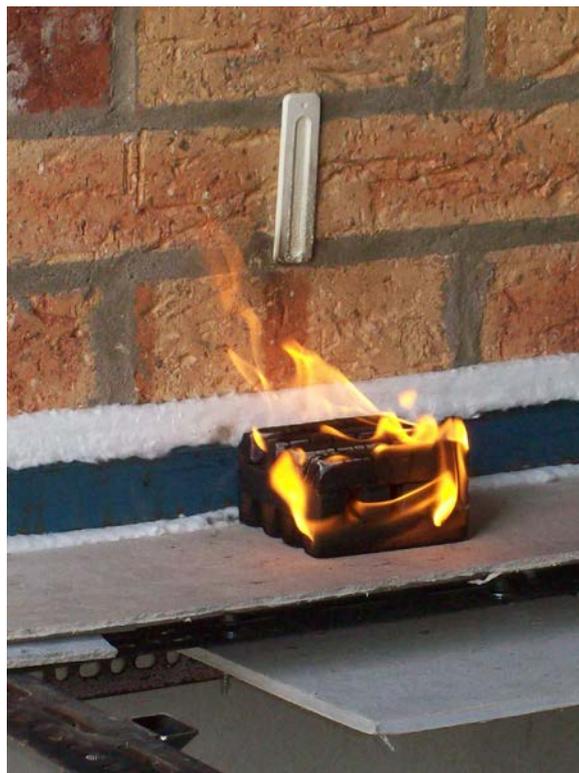
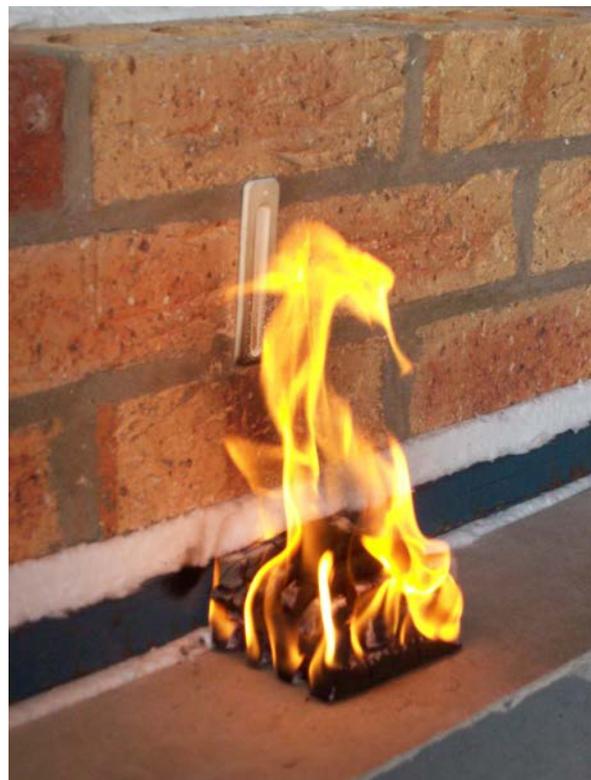
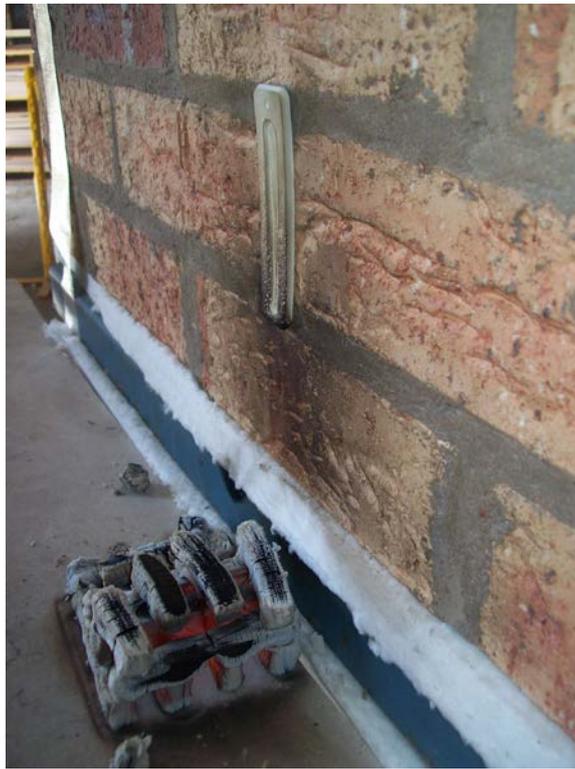
Figure 8: Test at 30 seconds.

Figure 9: Test at 4 minutes.

**Figure 10: Test at 7 minutes.**

**Figure 11: Test at 13 minutes.**

Figure 12: Weepguard/wall specimen at 20 minutes.

Photos of the test and post test are shown in Figures 8 to 14. The main points to be noted are:

- The Weepguard barrier did not ignite during the peak ( $12.5\text{kW/m}^2$ ) radiant heat phase or post this phase for a period of 60 minutes.
- Inspection of the Weepguard barrier after the test reveals the specimen was intact and retained its integrity. Slight lifting of the Weepguard barrier edge at both lower and upper edge had occurred, however this was minimal at less than 2 mm lift and not directly above the weephole cavity and hence the weephole cavity was not exposed in any way (Figure 13).

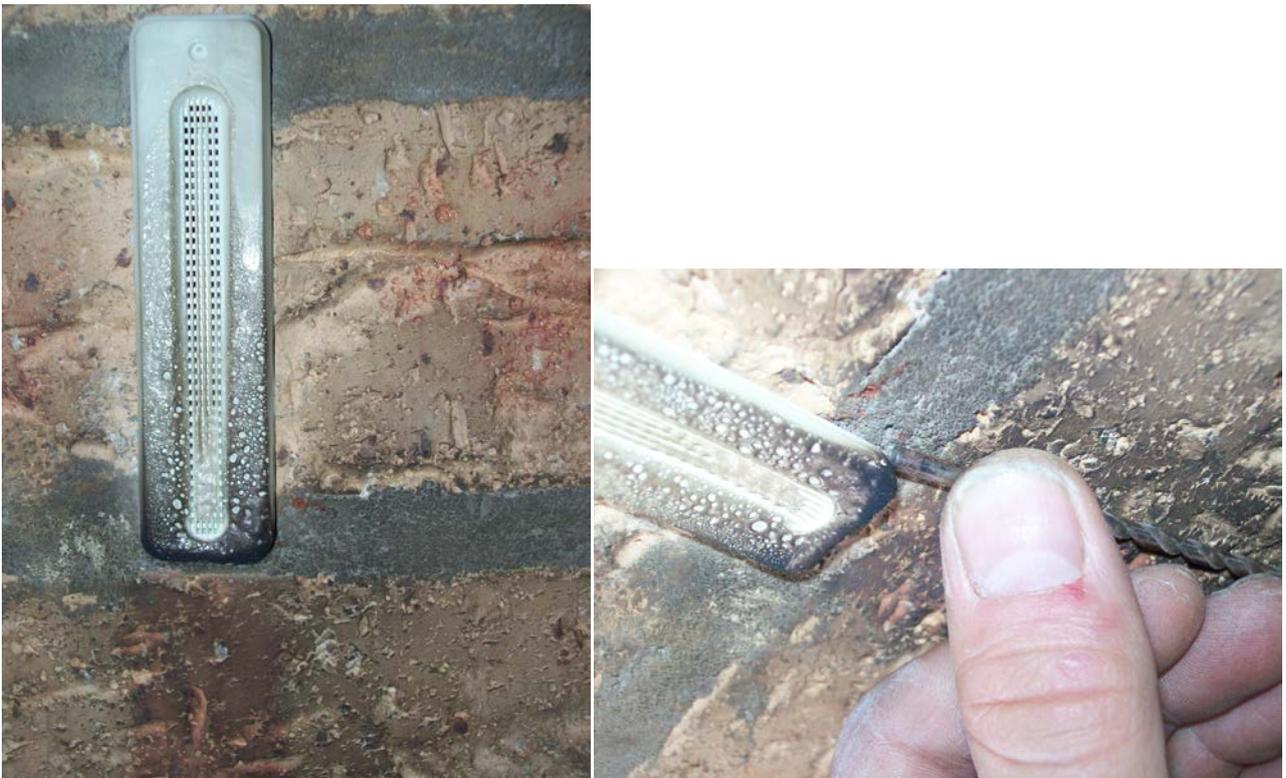
Figure 13: Post test Weepguard inspection.

- The integrated mesh although had signs of deformation and slight melting retained its integrity and the mesh holes size did not increase and in fact slight melting caused some holes to seal. (Figure 13). Post test assessment of the mesh integrity for both a hot and cold Weepguard specimen did not reveal specimen deterioration or any hole enlargement.
